**Flood Control Project Maintenance
Levee Inspections**

Maintenance Issue Types Only, Levee Inspection Report By Mile - Fall 2019

Sutter Maintenance Yard East Levee Sacramento River

Waterway	Bank	Unit Miles	Inspection Start/End	Inspector
Unit No. 01 Sacramento River	Left	19.85	10/16/2019 10/16/2019	Makar Sokol

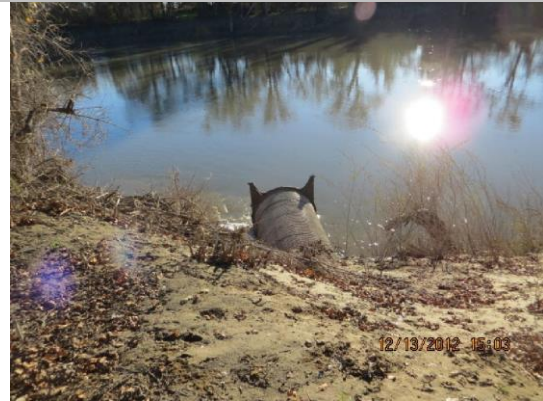
Photo 1 of 3 : UCIP_FA_2019_56010_46962.jpg

Comment Code					
Inspector Comment					
DS_ID:17307 FS_ID:56010 EP_NO: 9534 Repair Type: Urgent Crossing Status: Found UCIP Comments: 07/29/2019 Record has been updated from No Action Needed to Urgent, pipe wall at inlet has failed. No permit has been identified authorizing pipe. Records show that this is an LMA responsible structure and not a private owner drainage structure. DWR DMP has completed internal inspection of structure (see report). Need to review record and update current owner of structure. (O. Magana - DWR UCIP)10/27/2017 This structure is inspected annually under the Structure and Channel Summer Inspection (part of the Levee Inspection Program) conducted by the DWR Flood Project Integrity and Inspection Branch (FPIIB). (DWR UCIP - O. Magana) 04/24/2017 Both sides of crossing were underwater during site visit. Will need to revisit after water levels drop. (DWR Sutter Yard- A Freitag)11/07/2016 Crossing appears to be in good condition. (DWR Sutter Yard- A Freitag)06/06/2016 Crossing appears to be in good condition.04/06/2015 Good Condition. No issues. Semi circle CMP half riser in inlet structure on LS. Inlet opening has no trash rack, this may cause safety issue.06/30/2014 Same as last inspection.12/30/2013 Same as last inspection.07/29/2013 Same as last inspection. FIELD_STRUCT_DESC: [Butte Slough Drainage Structure] 78-inch drainage pipe of an unknown material through the levee, 3 feet below the crown. Flap gate on the waterside (WS). Corrugated metal pipe (CMP) half riser (in a semi-circle configuration) in the inlet structure on the landside (LS). (78-inch pipe [HLM 0.44] authorized under Automatic Board Order (ABO) issued as Permit No. 9534, 1974 - Caleta). [Additional Reference(s): DWR Levee Log, 2002. USACE Sacramento O&M Manual 136, March 1960 (HLM 0.44)]. FS Date: 7/29/2019 11:05:00 AM

WS view: overview towards CMP sewer pipe

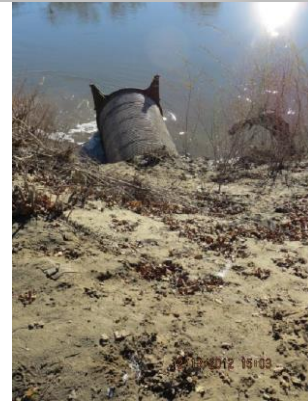
Photo 2 of 3 : UCIP_FA_2019_56010_46960.jpg

Comment Code						
Inspector Comment						
DS_ID:17307 FS_ID:56010 EP_NO: 9534 Repair Type: Urgent Crossing Status: Found UCIP Comments: 07/29/2019 Record has been updated from No Action Needed to Urgent, pipe wall at inlet has failed. No permit has been identified authorizing pipe. Records show that this is an LMA responsible structure and not a private owner drainage structure. DWR DMP has completed internal inspection of structure (see report). Need to review record and update current owner of structure. (O. Magana - DWR UCIP)10/27/2017 This structure is inspected annually under the Structure and Channel Summer Inspection (part of the Levee Inspection Program) conducted by the DWR Flood Project Integrity and Inspection Branch (FPIIB). (DWR UCIP - O. Magana) 04/24/2017 Both sides of crossing were underwater during site visit. Will need to revisit after water levels drop. (DWR Sutter Yard- A Freitag)11/07/2016 Crossing appears to be in good condition. (DWR Sutter Yard- A Freitag)06/06/2016 Crossing appears to be in good condition.04/06/2015 Good Condition. No issues. Semi circle CMP half riser in inlet structure on LS. Inlet opening has no trash rack, this may cause safety issue.06/30/2014 Same as last inspection.12/30/2013 Same as last inspection.07/29/2013 Same as last inspection. FIELD_STRUCT_DESC: [Butte Slough Drainage Structure] 78-inch drainage pipe of an unknown material through the levee, 3 feet below the crown. Flap gate on the waterside (WS). Corrugated metal pipe (CMP) half riser (in a semi-circle configuration) in the inlet structure on the landside (LS). (78-inch pipe [HLM 0.44] authorized under Automatic Board Order (ABO) issued as Permit No. 9534, 1974 - Caleta). [Additional Reference(s): DWR Levee Log, 2002. USACE Sacramento O&M Manual 136, March 1960 (HLM 0.44)]. FS Date: 7/29/2019 11:05:00 AM

WS view: water flowing from CMP sewer pipe

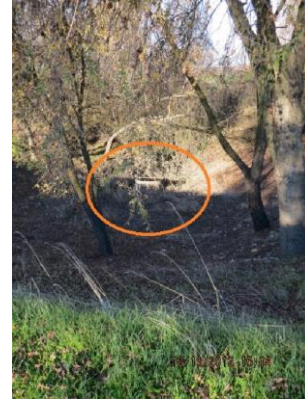
Photo 3 of 3 : UCIP_FA_2019_56010_46961.jpg

DS_ID:17307
 FS_ID:56010
 EP_NO: 9534
 Repair Type: Urgent
 Crossing Status: Found
 UCIP Comments: 07/29/2019 Record has been updated from No Action Needed to Urgent, pipe wall at inlet has failed. No permit has been identified authorizing pipe. Records show that this is an LMA responsible structure and not a private owner drainage structure. DWR DMP has completed internal inspection of structure (see report). Need to review record and update current owner of structure. (O. Magana - DWR UCIP)10/27/2017 This structure is inspected annually under the Structure and Channel Summer Inspection (part of the Levee Inspection Program) conducted by the DWR Flood Project Integrity and Inspection Branch (FPIIB). (DWR UCIP - O. Magana) 04/24/2017 Both sides of crossing were underwater during site visit. Will need to revisit after water levels drop. (DWR Sutter Yard- A Freitag)11/07/2016 Crossing appears to be in good condition. (DWR Sutter Yard- A Freitag)06/06/2016 Crossing appears to be in good condition.04/06/2015 Good Condition. No issues. Semi circle CMP half riser in inlet structure on LS. Inlet opening has no trash rack, this may cause safety issue.06/30/2014 Same as last inspection.12/30/2013 Same as last inspection.07/29/2013 Same as last inspection.

LS view: overview

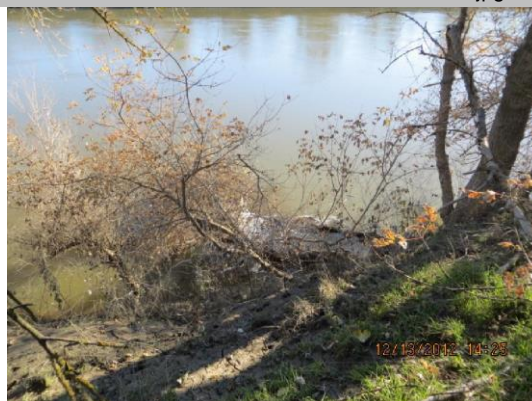
Photo 1 of 3 : UCIP_FA_2019_56013_46992.jpg

DS_ID:17320
FS_ID:56013
EP_NO: 9543
Repair Type: Urgent
Crossing Status: Found
UCIP Comments: 07/29/2019 same as 2018 inspection, Urgent. No access is available to WS due to dense vegetation, assume WS pipe is still completely deteriorated. Recommend internal inspection to determine the damage, if any, through the levee. (O. Magana - DWR UCIP)08/30/2018 WS vegetation too thick to clearly inspect WS pipe so assume same condition as last inspections so crossing remains Urgent due to pipe integrity. WS levee slope looks good. No signs of levee threat to the road crown. LS headwall looks in good condition (D. Sanoski - DWR UCIP).04/24/2017 WS was underwater during the site visit but I do not believe that any repairs have been made to this crossing yet. (DWR Sutter Yard- AFreitag)11/07/2016 No repairs have been made here yet. (DWR Sutter Yard- AFreitag)06/17/2016 River levels were down and the WS pipe end was exposed. WS end is completely rotten and damaged and flap gate has fallen off the end of the pipe (see pics). Pipe needs to be replaced or repaired. (DWR Sutter Yard - afreitag)04/05/2016 Erosion on WS slope still present. Pipe still fully submerged on WS and discharging into river during site visit. (DWR UCIP - kfazel)04/06/2015 Pipe leaks during high water. DWR employee said he suspects that the flap gate has rotted and fallen off WS end of pipe. Could not locate WS end of pipe to confirm. Water was flowing through this drain during field survey. (DWR Sutter Yard - afreitag)06/30/2014 Same as last inspection. (DWR Sutter Yard - afreitag)12/30/2013 Same as last inspection. (DWR Sutter Yard - afreitag)07/29/2013 Same as last inspection. (DWR Sutter Yard - afreitag) 12/13/2012 Water was flowing through this drain during field survey. (DWR UCIP - pamatya)

FIELD_STRUCT_DESC: 30-inch corrugated metal drainage pipe (at 45 degrees) through the levee, 25.2 feet below the crown. Flap gate on the waterside (WS), not found in 2016. (30-inch pipe [HLM 1.38] authorized under Automatic Board Order (ABO) issued as Permit No. 9543, 1974 - Harada). [Additional Reference(s): DWR Levee Log, 2002. USACE Sacramento O&M Manual 136, revision March 1960 (HLM 1.38)]
FS Date: 7/29/2019 11:08:00 AM

WS view: overview of river bank

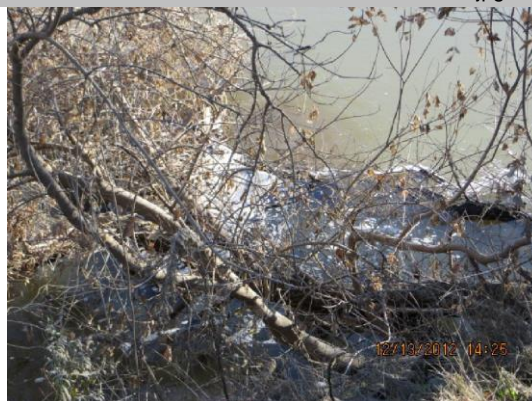
Photo 2 of 3 : UCIP_FA_2019_56013_46991.jpg

DS_ID:17320
FS_ID:56013
EP_NO: 9543
Repair Type: Urgent
Crossing Status: Found
UCIP Comments: 07/29/2019 same as 2018 inspection, Urgent. No access is available to WS due to dense vegetation, assume WS pipe is still completely deteriorated. Recommend internal inspection to determine the damage, if any, through the levee. (O. Magana - DWR UCIP)08/30/2018 WS vegetation too thick to clearly inspect WS pipe so assume same condition as last inspections so crossing remains Urgent due to pipe integrity. WS levee slope looks good. No signs of levee threat to the road crown. LS headwall looks in good condition (D. Sanoski - DWR UCIP).04/24/2017 WS was underwater during the site visit but I do not believe that any repairs have been made to this crossing yet. (DWR Sutter Yard- AFreitag)11/07/2016 No repairs have been made here yet. (DWR Sutter Yard- AFreitag)06/17/2016 River levels were down and the WS pipe end was exposed. WS end is completely rotten and damaged and flap gate has fallen off the end of the pipe (see pics). Pipe needs to be replaced or repaired. (DWR Sutter Yard - afreitag)04/05/2016 Erosion on WS slope still present. Pipe still fully submerged on WS and discharging into river during site visit. (DWR UCIP - kfazel)04/06/2015 Pipe leaks during high water. DWR employee said he suspects that the flap gate has rotted and fallen off WS end of pipe. Could not locate WS end of pipe to confirm. Water was flowing through this drain during field survey. (DWR Sutter Yard - afreitag)06/30/2014 Same as last inspection. (DWR Sutter Yard - afreitag)12/30/2013 Same as last inspection. (DWR Sutter Yard - afreitag)07/29/2013 Same as last inspection. (DWR Sutter Yard - afreitag) 12/13/2012 Water was flowing through this drain during field survey. (DWR UCIP - pamatya)

WS view: water flowing from outlet pipe (pipe fully submerge)

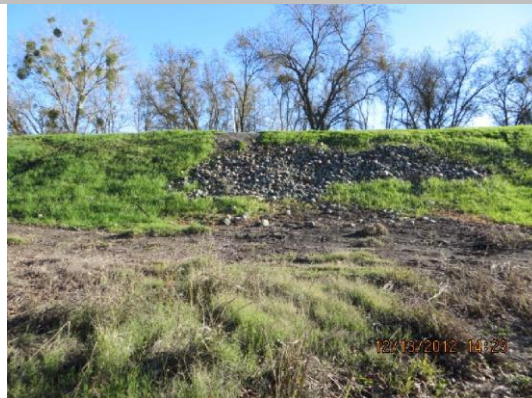
Photo 3 of 3 : UCIP_FA_2019_56013_46990.jpg

DS_ID:17320
FS_ID:56013
EP_NO: 9543
Repair Type: Urgent
Crossing Status: Found
UCIP Comments: 07/29/2019 same as 2018 inspection, Urgent. No access is available to WS due to dense vegetation, assume WS pipe is still completely deteriorated. Recommend internal inspection to determine the damage, if any, through the levee. (O. Magana - DWR UCIP)08/30/2018 WS vegetation too thick to clearly inspect WS pipe so assume same condition as last inspections so crossing remains Urgent due to pipe integrity. WS levee slope looks good. No signs of levee threat to the road crown. LS headwall looks in good condition (D. Sanoski - DWR UCIP).04/24/2017 WS was underwater during the site visit but I do not believe that any repairs have been made to this crossing yet. (DWR Sutter Yard- AFreitag)11/07/2016 No repairs have been made here yet. (DWR Sutter Yard- AFreitag)06/17/2016 River levels were down and the WS pipe end was exposed. WS end is completely rotten and damaged and flap gate has fallen off the end of the pipe (see pics). Pipe needs to be replaced or repaired. (DWR Sutter Yard - afreitag)04/05/2016 Erosion on WS slope still present. Pipe still fully submerged on WS and discharging into river during site visit. (DWR UCIP - kfazel)04/06/2015 Pipe leaks during high water. DWR employee said he suspects that the flap gate has rotted and fallen off WS end of pipe. Could not locate WS end of pipe to confirm. Water was flowing through this drain during field survey. (DWR Sutter Yard - afreitag)06/30/2014 Same as last inspection. (DWR Sutter Yard - afreitag)12/30/2013 Same as last inspection. (DWR Sutter Yard - afreitag)07/29/2013 Same as last inspection. (DWR Sutter Yard - afreitag) 12/13/2012 Water was flowing through this drain during field survey. (DWR UCIP - pamatya)

LS view: overview of levee slope

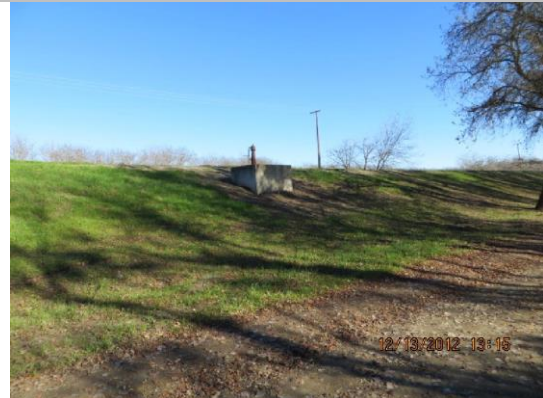
Photo 1 of 3 : UCIP_FA_2019_56018_47027.jpg

Comment Code						
Inspector Comment						
DS_ID:17309 FS_ID:56018 EP_NO: 9541 Repair Type: Non-Urgent Crossing Status: Found UCIP Comments: 07/29/2019 Record remains Non-Urgent, need to audit record to correct current owner of structure. Need to clarify owner for this crossing. Crossing was issued an ABO in 1974 however, this structure seems to be primarily used for drainage. Crossing is listed as LMA responsible and private owner. Crossing appears to be in good condition. (O. Magana - DWR UCIP)04/24/2017 Still no sign of WS pipe end or flap gate. LS appears to be in good condition. (DWR Sutter Yard- AFreitag) 11/07/2016 LS culvert measured to be 30"wide X 30"tall. WS end is not visible so could not be measured. (DWR Sutter Yard- AFreitag)06/06/2016 Cannot locate the WS headwall/flap gate. Appears to have been silted over.04/06/2015 Same as last inspection. Concrete surg box on WS. Flap gate in concrete "U" headwall at the waterward end- not found.06/30/2014 Same as last inspection.12/30/2013 Same as last inspection.07/29/2013 Same as last inspection. FIELD_STRUCT_DESC: 30-inch reinforced concrete box drainage culvert through the levee, 14.3 feet below the crown. 30-inch corrugated metal pipe connects concrete culvert from slide gate out to flap gate on the waterside (WS) end. Slide gate in a concrete riser on the waterside (WS) slope. (30-inch pipe [HLM 2.49] authorized under Automatic Board Order (ABO) issued as Permit No. 9541, 1974 - Wilbur, McGowan, Zinke). [Additional Reference(s): DWR Levee Logs, 2002. USACE Sacramento O&M Manual 136, March 1960 (HLM 2.49)]. FS Date: 7/29/2019 11:12:00 AM

WS view: overview- concrete surg tank

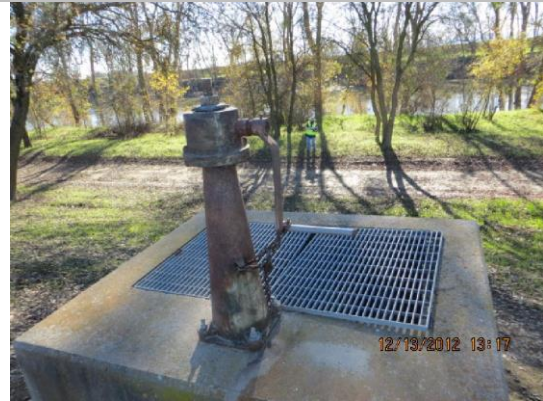
Photo 2 of 3 : UCIP_FA_2019_56018_47026.jpg

Comment Code						
Inspector Comment						
DS_ID:17309 FS_ID:56018 EP_NO: 9541 Repair Type: Non-Urgent Crossing Status: Found UCIP Comments: 07/29/2019 Record remains Non-Urgent, need to audit record to correct current owner of structure. Need to clarify owner for this crossing. Crossing was issued an ABO in 1974 however, this structure seems to be primarily used for drainage. Crossing is listed as LMA responsible and private owner. Crossing appears to be in good condition. (O. Magana - DWR UCIP)04/24/2017 Still no sign of WS pipe end or flap gate. LS appears to be in good condition. (DWR Sutter Yard- AFreitag) 11/07/2016 LS culvert measured to be 30"wide X 30"tall. WS end is not visible so could not be measured. (DWR Sutter Yard- AFreitag)06/06/2016 Cannot locate the WS headwall/flap gate. Appears to have been silted over.04/06/2015 Same as last inspection. Concrete surg box on WS. Flap gate in concrete "U" headwall at the waterward end- not found.06/30/2014 Same as last inspection.12/30/2013 Same as last inspection.07/29/2013 Same as last inspection. FIELD_STRUCT_DESC: 30-inch reinforced concrete box drainage culvert through the levee, 14.3 feet below the crown. 30-inch corrugated metal pipe connects concrete culvert from slide gate out to flap gate on the waterside (WS) end. Slide gate in a concrete riser on the waterside (WS) slope. (30-inch pipe [HLM 2.49] authorized under Automatic Board Order (ABO) issued as Permit No. 9541, 1974 - Wilbur, McGowan, Zinke). [Additional Reference(s): DWR Levee Logs, 2002. USACE Sacramento O&M Manual 136, March 1960 (HLM 2.49)]. FS Date: 7/29/2019 11:12:00 AM

WS view: overview- concrete surg tank

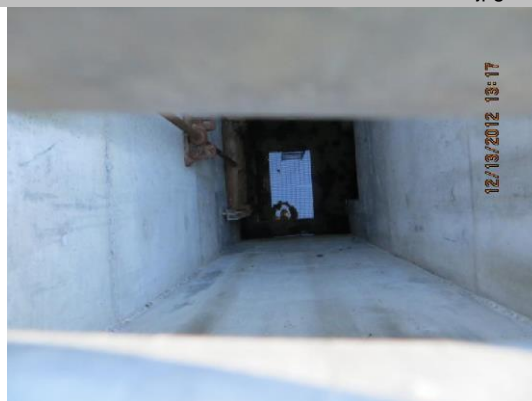
Photo 3 of 3 : UCIP_FA_2019_56018_47025.jpg

Comment Code						
Inspector Comment						
DS_ID:17309 FS_ID:56018 EP_NO: 9541 Repair Type: Non-Urgent Crossing Status: Found UCIP Comments: 07/29/2019 Record remains Non-Urgent, need to audit record to correct current owner of structure. Need to clarify owner for this crossing. Crossing was issued an ABO in 1974 however, this structure seems to be primarily used for drainage. Crossing is listed as LMA responsible and private owner. Crossing appears to be in good condition. (O. Magana - DWR UCIP)04/24/2017 Still no sign of WS pipe end or flap gate. LS appears to be in good condition. (DWR Sutter Yard- AFreitag) 11/07/2016 LS culvert measured to be 30"wide X 30"tall. WS end is not visible so could not be measured. (DWR Sutter Yard- AFreitag)06/06/2016 Cannot locate the WS headwall/flap gate. Appears to have been silted over.04/06/2015 Same as last inspection. Concrete surg box on WS. Flap gate in concrete "U" headwall at the waterward end- not found.06/30/2014 Same as last inspection.12/30/2013 Same as last inspection.07/29/2013 Same as last inspection. FIELD_STRUCT_DESC: 30-inch reinforced concrete box drainage culvert through the levee, 14.3 feet below the crown. 30-inch corrugated metal pipe connects concrete culvert from slide gate out to flap gate on the waterside (WS) end. Slide gate in a concrete riser on the waterside (WS) slope. (30-inch pipe [HLM 2.49] authorized under Automatic Board Order (ABO) issued as Permit No. 9541, 1974 - Wilbur, McGowan, Zinke). [Additional Reference(s): DWR Levee Logs, 2002. USACE Sacramento O&M Manual 136, March 1960 (HLM 2.49)]. FS Date: 7/29/2019 11:12:00 AM

WS view: slide gate inside concrete surg tank

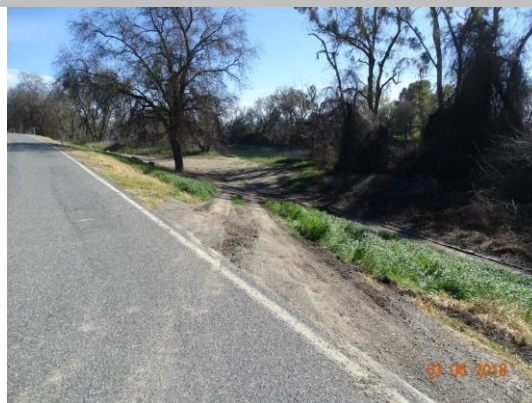
Photo 1 of 1 : FA_2019_ST0003_264_104_20190822_00029.jpg

LM Start	2.84	Rating **	M	Issue No.	104
LM End	2.84	Issue Type +	Ma	Location *	WS
Category	Earthen Levee			GPS Latitude/Longitude	
				Start	End
Item	Slope Stability			39.191162 °	39.191162 °
				-121.980365 °	-121.980365 °
DWR ID	DWR_ST0003_01_s_2018_104				
Comment Code					
S3 : Repair the levee slope damaged by vehicle traffic and prevent access where possible.					
Inspector Comment

View of the erosion along the waterside slope caused by vehicle traffic.

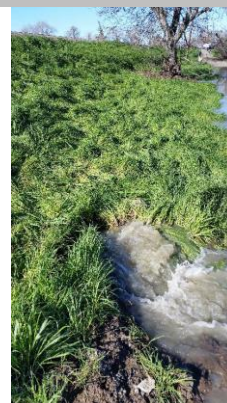
Photo 1 of 3 : UCIP_FA_2019_56020_76919.jpg

DS_ID:17311
FS_ID:56020
EP_NO: N/A
Repair Type: Urgent
Crossing Status: Found
UCIP Comments: 07/30/2019 Record remains Urgent due to pipe integrity. DMP internal inspection was completed. Internal inspection noted surface damage corrosion and hole void visible, refer to DMP internal inspection report. New gate installed to control flood water entering pipe and flooding LS. No permit has been identified authorizing pipe. Pipe was not in use/clogged prior to the 2017 high water event. Owner will need to coordinate with CVFPB to properly remove or abandon pipe per Title 23 requirements. (O. Magana - DWR UCIP)08/30/2018 Pipe found; at a different Lat/Long than is listed, however. Revised Lat/Long is (39.196865, -121.985280; CLM 3.32). WS pipe end is visible and has a functioning slide gate; LS pipe end is exposed with no closure device or headwall. Keeping as Urgent because the LS pipe discharges into a hole and could pose a threat to the levee prism during a high water event. There are also cracks on the crown that could be related to the pipe beneath. Recommend an internal pipe inspection to be sure of the levee integrity (D.Sanoski - DWR UCIP).04/06/2017 Pipe was found in January 2017 during a high water event when water uncovered the buried WS end which led to uncontrolled water flow through during the high water event. The WS pipe opening was temporarily blocked off by plywood and sandbags until the pipe can be properly plugged or abandoned. Pics updated. (DWR Sutter Yard- Afreitag)11/07/2016 Unable to locate. (DWR Sutter Yard- Afreitag)06/06/2016 Unable to locate.04/06/2015 Unable to locate.06/30/2014 Unable to locate.12/30/2013 Unable to locate.07/29/2013 Same as last inspection. Unable to locate.

LS view of water exiting the pipe.

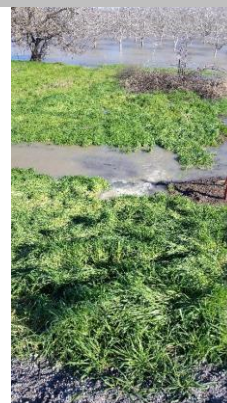
Photo 2 of 3 : UCIP_FA_2019_56020_76920.jpg

DS_ID:17311
FS_ID:56020
EP_NO: N/A
Repair Type: Urgent
Crossing Status: Found
UCIP Comments: 07/30/2019 Record remains Urgent due to pipe integrity. DMP internal inspection was completed. Internal inspection noted surface damage corrosion and hole void visible, refer to DMP internal inspection report. New gate installed to control flood water entering pipe and flooding LS. No permit has been identified authorizing pipe. Pipe was not in use/clogged prior to the 2017 high water event. Owner will need to coordinate with CVFPB to properly remove or abandon pipe per Title 23 requirements. (O. Magana - DWR UCIP)08/30/2018 Pipe found; at a different Lat/Long than is listed, however. Revised Lat/Long is (39.196865, -121.985280; CLM 3.32). WS pipe end is visible and has a functioning slide gate; LS pipe end is exposed with no closure device or headwall. Keeping as Urgent because the LS pipe discharges into a hole and could pose a threat to the levee prism during a high water event. There are also cracks on the crown that could be related to the pipe beneath. Recommend an internal pipe inspection to be sure of the levee integrity (D.Sanoski - DWR UCIP).04/06/2017 Pipe was found in January 2017 during a high water event when water uncovered the buried WS end which led to uncontrolled water flow through during the high water event. The WS pipe opening was temporarily blocked off by plywood and sandbags until the pipe can be properly plugged or abandoned. Pics updated. (DWR Sutter Yard- Afreitag)11/07/2016 Unable to locate. (DWR Sutter Yard- Afreitag)06/06/2016 Unable to locate.04/06/2015 Unable to locate.06/30/2014 Unable to locate.12/30/2013 Unable to locate.07/29/2013 Same as last inspection. Unable to locate. FIELD_STRUCT_DESC: 24-inch corrugated metal drainage pipe through the levee, 12.4 feet below the crown. Slide gate on the waterside (WS) end. (Automatic Board Order (ABO) issued as Permit No. 9539, 1974 - Locvich). [Additional Reference(s): DWR Levee Log, 2002. USACE Sacramento O&M Manual 136, March 1960 (HLM 3.25)]. FS Date: 7/30/2019 10:49:00 AM

LS view from levee shoulder

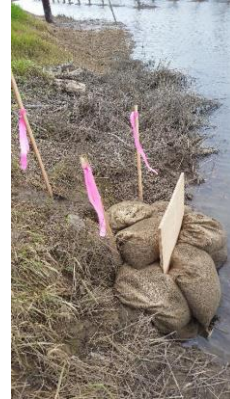
Photo 3 of 3 : UCIP_FA_2019_56020_76921.jpg

DS_ID:17311
FS_ID:56020
EP_NO: N/A
Repair Type: Urgent
Crossing Status: Found
UCIP Comments: 07/30/2019 Record remains Urgent due to pipe integrity. DMP internal inspection was completed. Internal inspection noted surface damage corrosion and hole void visible, refer to DMP internal inspection report. New gate installed to control flood water entering pipe and flooding LS. No permit has been identified authorizing pipe. Pipe was not in use/clogged prior to the 2017 high water event. Owner will need to coordinate with CVFPB to properly remove or abandon pipe per Title 23 requirements. (O. Magana - DWR UCIP)08/30/2018 Pipe found; at a different Lat/Long than is listed, however. Revised Lat/Long is (39.196865, -121.985280; CLM 3.32). WS pipe end is visible and has a functioning slide gate; LS pipe end is exposed with no closure device or headwall. Keeping as Urgent because the LS pipe discharges into a hole and could pose a threat to the levee prism during a high water event. There are also cracks on the crown that could be related to the pipe beneath. Recommend an internal pipe inspection to be sure of the levee integrity (D.Sanoski - DWR UCIP).04/06/2017 Pipe was found in January 2017 during a high water event when water uncovered the buried WS end which led to uncontrolled water flow through during the high water event. The WS pipe opening was temporarily blocked off by plywood and sandbags until the pipe can be properly plugged or abandoned. Pics updated. (DWR Sutter Yard- Afreitag)11/07/2016 Unable to locate. (DWR Sutter Yard- Afreitag)06/06/2016 Unable to locate.04/06/2015 Unable to locate.06/30/2014 Unable to locate.12/30/2013 Unable to locate.07/29/2013 Same as last inspection. Unable to locate.

WS view of the temporary plug on WS end.

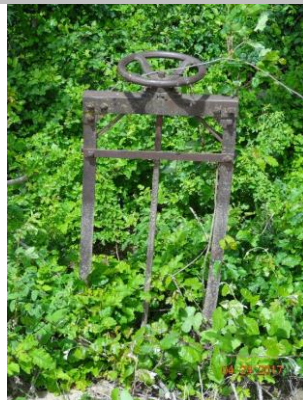
Photo 1 of 3 : UCIP_FA_2019_56022_77004.jpg

DS_ID:17313
FS_ID:56022
EP_NO: N/A
Repair Type: Non-Urgent
Crossing Status: Found
UCIP Comments: 07/30/2019 Record remains Non-Urgent, pipe has been abandoned. Coordinates have been updated from 39.201831, -121.984006 to 39.2016497, -121.9840750 based on the DMP Geophysics Study and UCIP field confirmation. Per the DMP Geophysics Study the pipe is still present through the levee. LMA will need to monitor levee section until funds become available to remove or properly abandon pipe through the levee. (O. Magana - DWR UCIP)04/24/2017 Slide gate structure found on WS about 10ft from levee toe. Vegetation was too thick to see if there were any more appurtenances associated with this crossing visible on the WS. Nothing was visible on the LS. House located above pipe alignment at LS levee toe. Crossing appears abandoned and should be done so properly. (DWR Sutter Yard- AFreitag)11/07/2016 Unable to locate. (DWR Sutter Yard- AFreitag)06/06/2016 Unable to locate.04/06/2015 Unable to locate.06/30/2014 Unable to locate.12/30/2013 Unable to locate07/29/2013 Same as last inspection. Unable to locate.

Slide gate structure found on WS

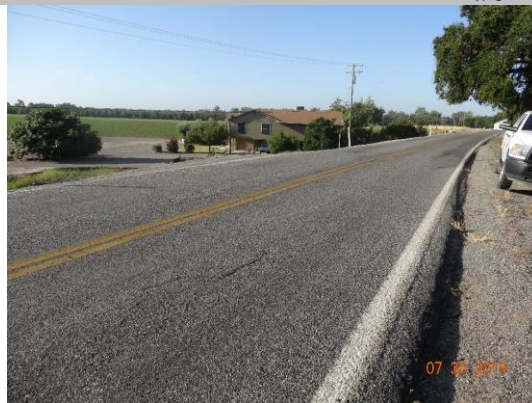
Photo 2 of 3 : UCIP_FA_2019_56022_80177.jpg

Overview of levee crown looking d/s towards crossing.

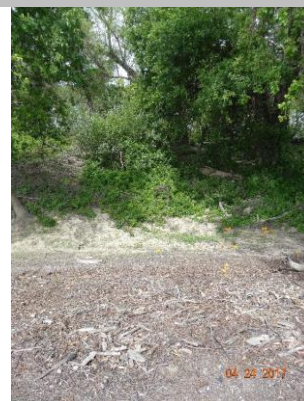
Photo 3 of 3 : UCIP_FA_2019_56022_77005.jpg

Item	DRAFT DWR UCIP LMA Responsibility		39.201650 °	39.201650 °								
			-121.984075 °	-121.984075 °								
DWR ID	17313											
Comment Code												
Inspector Comment												
DS_ID:17313 FS_ID:56022 EP_NO: N/A Repair Type: Non-Urgent Crossing Status: Found UCIP Comments: 07/30/2019 Record remains Non-Urgent, pipe has been abandoned. Coordinates have been updated from 39.201831, -121.984006 to 39.2016497, -121.9840750 based on the DMP Geophysics Study and UCIP field confirmation. Per the DMP Geophysics Study the pipe is still present through the levee. LMA will need to monitor levee section until funds become available to remove or properly abandon pipe through the levee. (O. Magana - DWR UCIP)04/24/2017 Slide gate structure found on WS about 10ft from levee toe. Vegetation was too thick to see if there were any more appurtenances associated with this crossing visible on the WS. Nothing was visible on the LS. House located above pipe alignment at LS levee toe. Crossing appears abandoned and should be done so properly. (DWR Sutter Yard- AFreitag)11/07/2016 Unable to locate. (DWR Sutter Yard- AFreitag)06/06/2016 Unable to locate.04/06/2015 Unable to locate.06/30/2014 Unable to locate.12/30/2013 Unable to locate07/29/2013 Same as last inspection. Unable to locate. FIELD_STRUCT_DESC: *ABANDONED* 18-inch corrugated metal drainage pipe through the levee, 15 feet below the crown. Slide gate on the waterside (WS) end. [Additional Reference(s): DWR Levee Log, 2002. USACE Sacramento O&M Manual 136, March 1960 (HLM 3.6)]. FS Date: 7/30/2019 10:52:00 AM

View of WS from levee shoulder

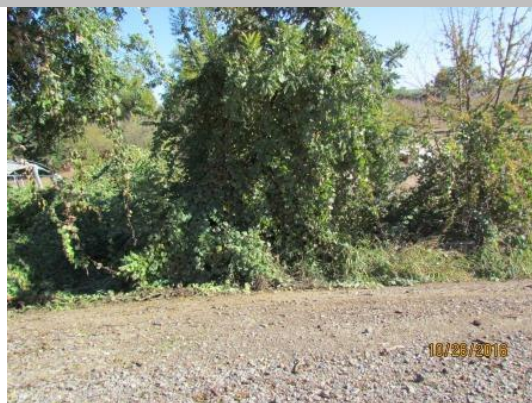
Photo 1 of 1 : FA_2019_ST0003_264_99_20190822_00025.jpg

View of the overgrown vegetation along the landside slope.

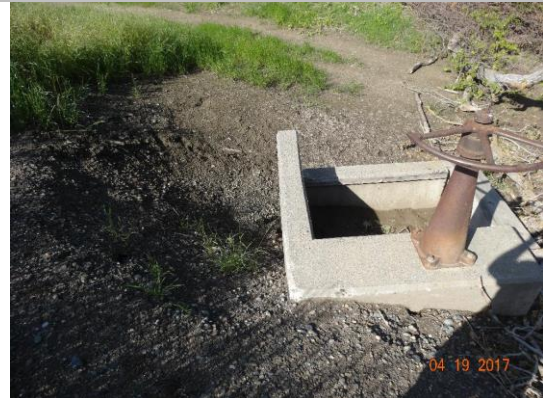
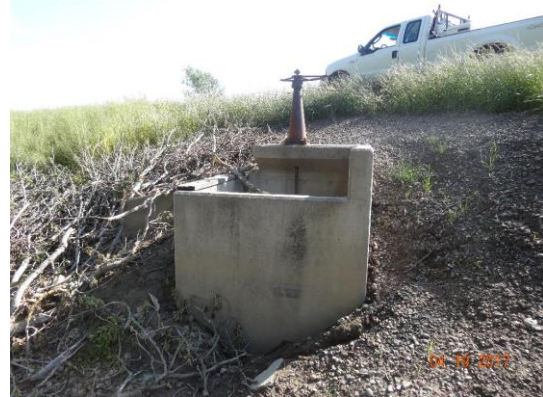
Depression around WS concrete box

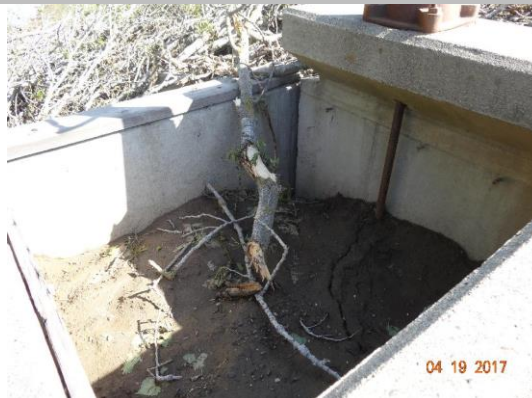
Photo 3 of 3 : UCIP_FA_2019_55543_77010.jpg

WS concrete box full of silt.

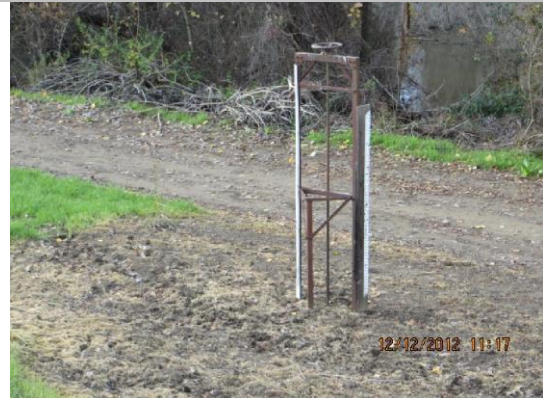
Photo 2 of 3 : UCIP_FA_2019_55552_47209.jpg

WS view: buried slide gate

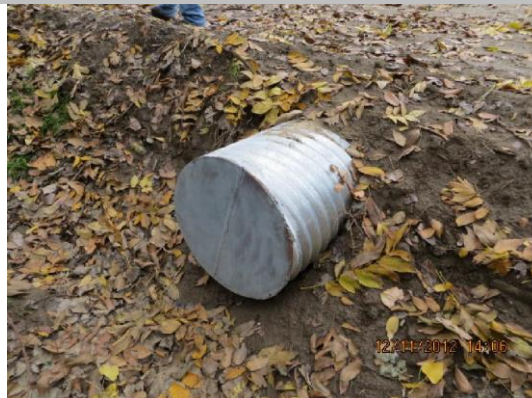
Photo 3 of 3 : UCIP_FA_2019_55554_47240.jpg

WS view: capped CMP pipe

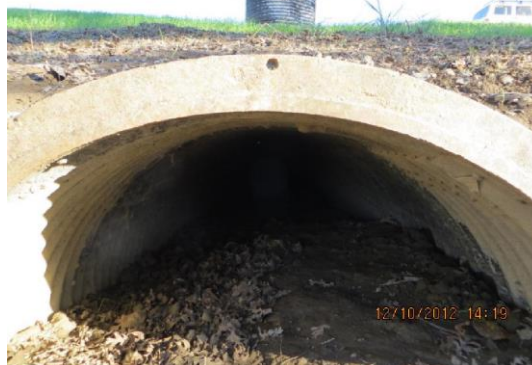
Photo 3 of 3 : UCIP_FA_2019_55576_47341.jpg

WS view: silted concrete lined CMP outlet pipe

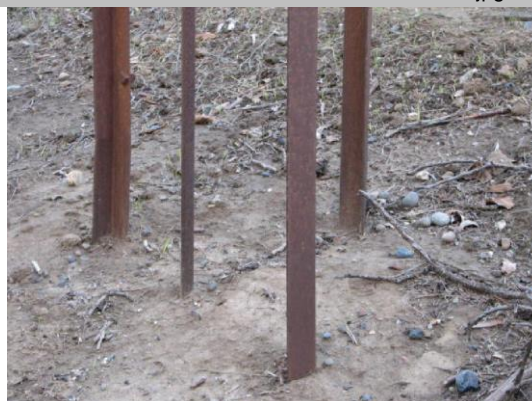
Photo 3 of 3 : UCIP_FA_2019_55599_47385.jpg

WS view: burried slide gate

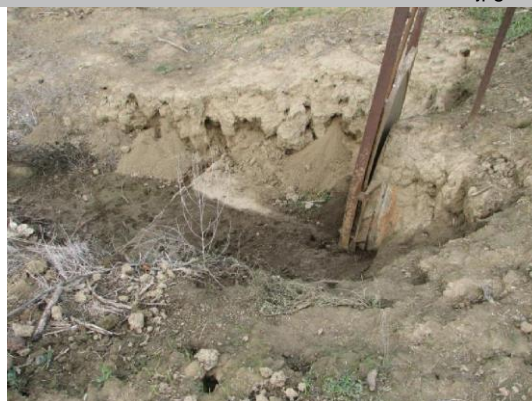
Photo 3 of 3 : UCIP_FA_2019_55610_47403.jpg

WS view: sloughing at outlet pipe

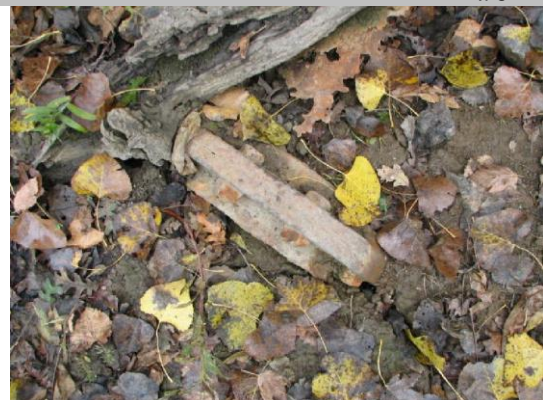
Photo 2 of 3 : UCIP_FA_2019_56037_47448.jpg

WS view: abandoned and ruined pipe

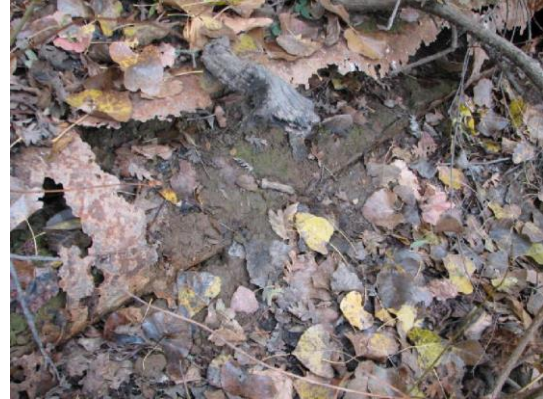
Photo 3 of 3 : UCIP_FA_2019_56037_47453.jpg

WS view: abandoned and ruined pipe

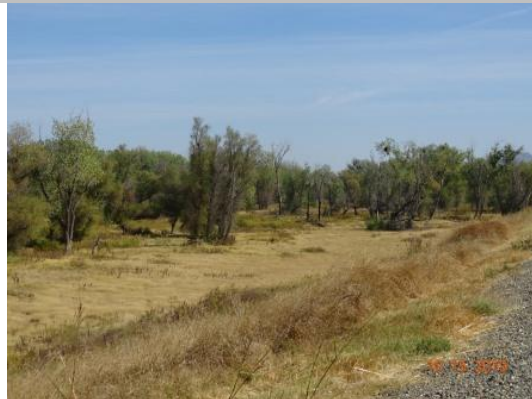
Photo 1 of 1 : FA_2019_ST0003_265_7_20191017_00013.jpg

View of the vegetation along the waterside slope. Fall 2019.

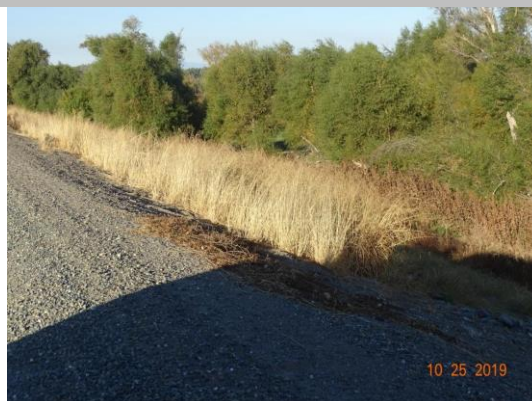
Photo 1 of 1 : FA_2019_ST0003_266_7_20191025_00008.jpg

View of the vegetation along the landside slope. Fall 2019.

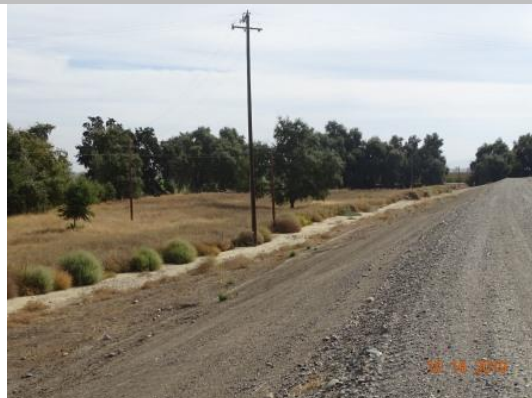
Photo 1 of 1 : FA_2019_ST0003_267_2_20191017_00003.jpg

View of the well-maintained landside levee slope, free of vegetation. Fall 2019.

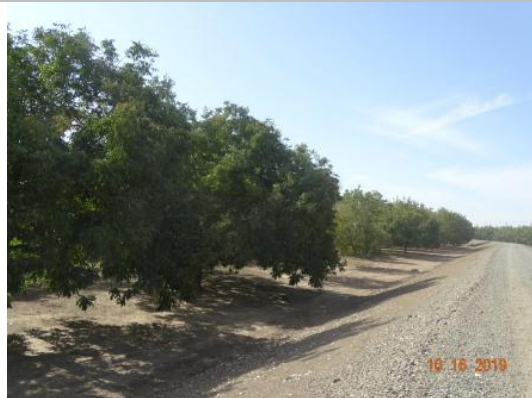
Photo 1 of 1 : FA_2019_ST0003_268_8_20191017_00004.jpg

View of the well-maintained landside levee slopes, free of vegetation. Fall 2019.
